# SAMPLE REVIEW: FOOT FRACTURE

Advanced Medical Imaging Consultation

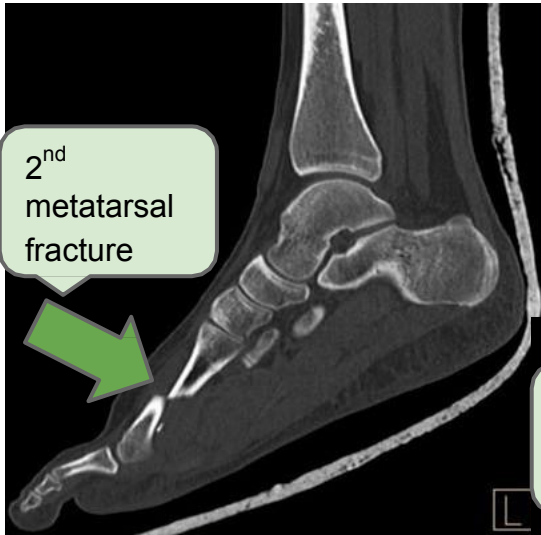
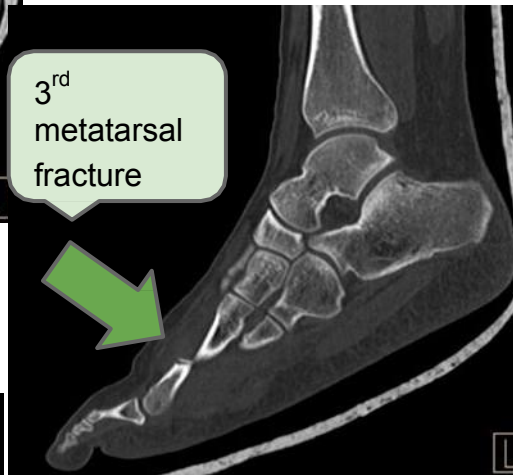
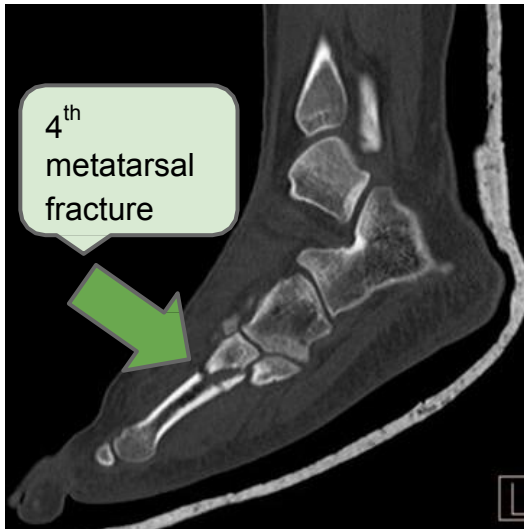
These images obtained in the sagittal plane of the right foot, demonstrating displaced 2<sup>nd</sup> and 3<sup>rd</sup> metatarsal shaft fractures, and nondisplaced proximal 4<sup>th</sup> metatarsal fracture.

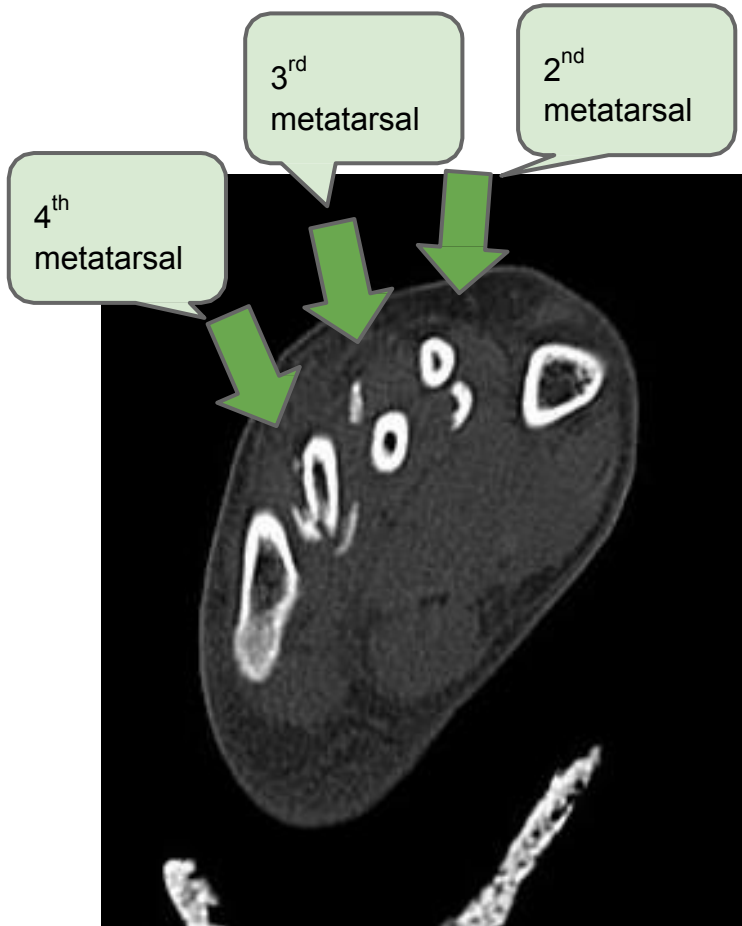
Coronal oblique plane

This image obtained in a coronal oblique plane shows all three metatarsal fractures. Coronal oblique simply means coronal plane with a slight angle. CT scans of the feet are often not taken in a true coronal plane due to positioning of the foot in the scanner.

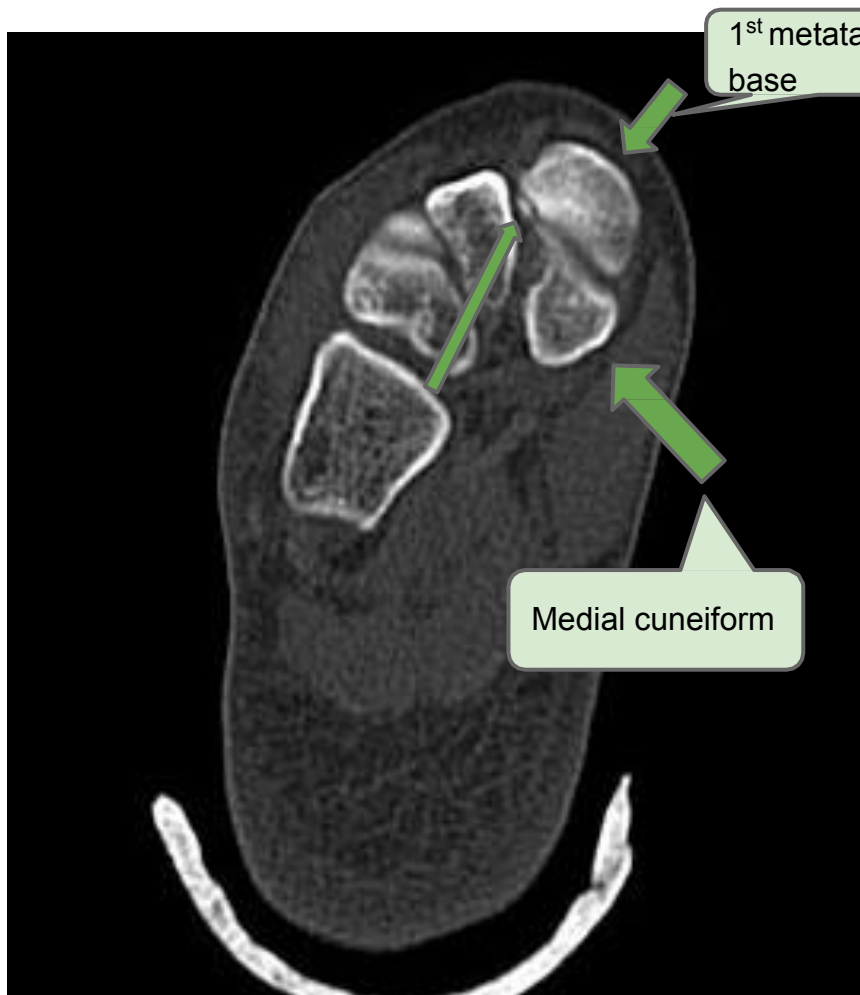
Coronal oblique plane

Green arrow shows a very subtle finding in this case. This is a questionable small avulsion fracture involving the medial base of the 1<sup>st</sup> metatarsal. This is located near the attachment site of the Lisfranc ligament. This is only seen in one plane however. Therefore, this case may have a very subtle Lisfranc type injury. Imaging cannot completely assess the severity of a Lisfranc injury, even when there is no displaced fracture as in this case. Physical examination with dynamic maneuvers to test the Lisfranc joint is necessary to assess for joint stability.

In summary, this case demonstrates acute trauma to the right foot, with several metatarsal fractures. Two of these fractures are displaced, indicating the need for surgical therapy with open reduction internal fixation (ORIF). In addition, there is a subtle fracture of the 1<sup>st</sup> metatarsal base, compatible with a mild Lisfranc type injury.

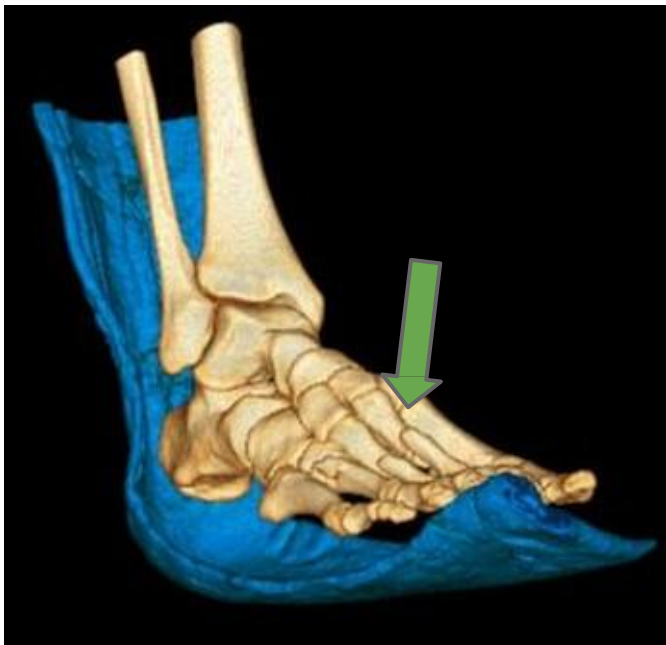
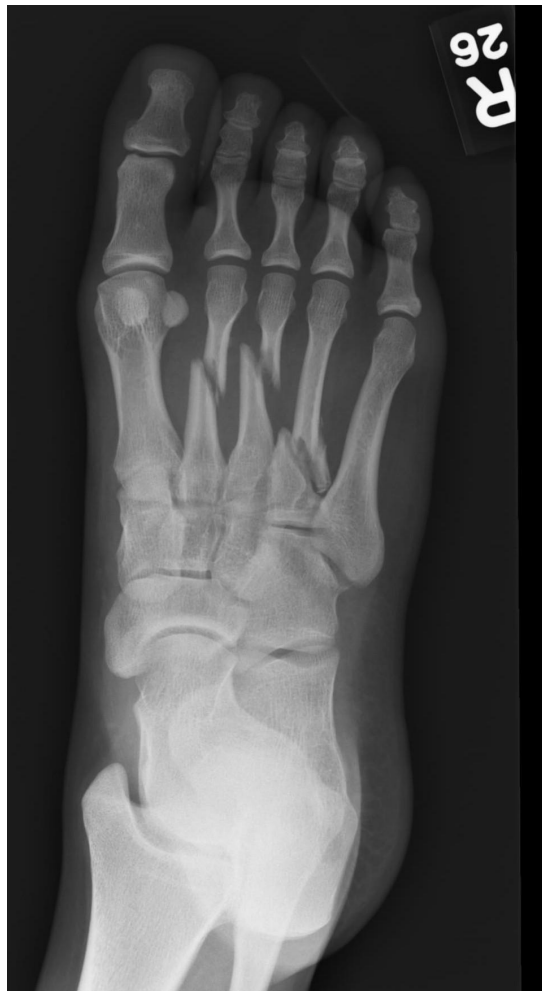
3-D images from the CT scan show the metatarsal fractures, although not as well demonstrated on plain x-ray obtained same day.
